Design-Level Hazardous Building Materials Survey

6445 NE MLK Jr. Blvd.
Portland, OR

February 2005
Project #: 19179.000

PORTLAND DEVELOPMENT COMMISSION
 HAZARDOUS MATERIALS SITE PLAN
 6445 NE MARTIN LUTHER KING JR BOULEVARD
 PORTLAND, OREGON

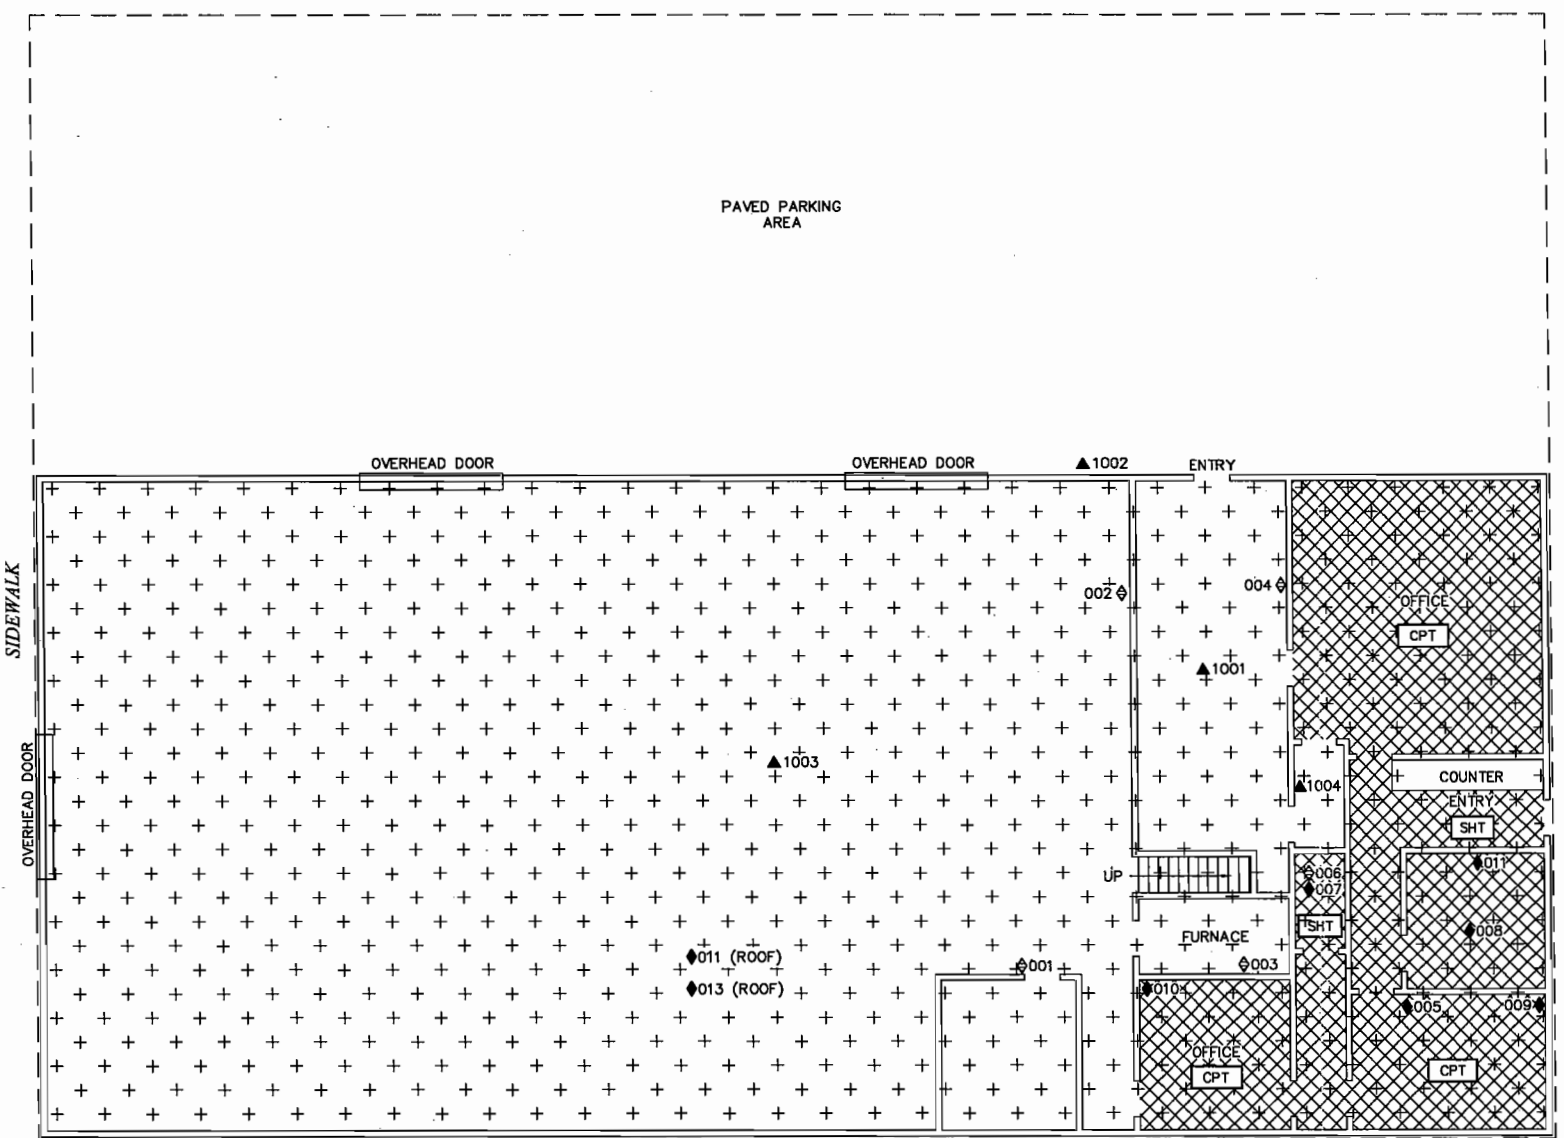
FIGURE HM1

Asbestos-containing vinyl floor tile and mastic was identified throughout the office portion of the building. The floor tile is located under carpet in most areas and is under non-asbestos sheet floor covering in the restroom and entry.

The roofing materials tested positive for asbestos. The roofing consists of asbestos-containing silver roof paint, asbestos-containing asphaltic roofing boards, and asbestos-containing roof penetration sealant.

Joint compound applied to gypsum board throughout the office area interior walls tested positive for asbestos. The positive joint compound samples tested 2% for asbestos by visual estimate. The gypsum wallboard tested negative for asbestos. Under current regulations, the EPA, DEQ, and OSHA classify a material as asbestos-containing if analytical results indicate the material contains greater than 1% asbestos by weight. Additional point count analysis of the material may reveal that the composite wall system contain less than 1% asbestos, in which case the gypsum board systems would not be considered an asbestos-containing material. However, activities disturbing the material including demolition would still require that the work is completed by OSHA trained workers using appropriate engineering controls.

1. THIS DRAWING IS DIAGRAMMATIC AND NOT PROPER SCALE. IT IS FOR GENERAL INFORMATION AND SAMPLE LOCATIONS.
2. ACCESSIBLE SPACES WERE SURVEYED FOR SUSPECT HAZARDOUS MATERIALS. WHEN OBSERVED, THE MATERIALS WERE NOTED ON THE DRAWING.
3. JOINT COMPOUND ON INTERIOR GYPSUM WALLS TESTED POSITIVE FOR ASBESTOS.

No abatement actions are recommended for temporary building occupancy. All asbestos-containing materials should be removed by a licensed abatement contractor prior to demolition of the structure.
